Manhole Inspection Summary

Manhole # S15Y__010MH

Insp Date: **6/25/08 8:26 AM**

Location Address: **2613 georgetown rd**

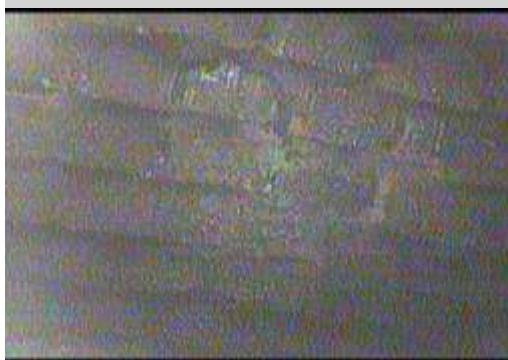
Defect 4

Infiltration: ☐ None ☐ Joint ☐ Cracks ☐ Mortar ☐ Roots ☒ **Wall**

infiltration @ barrel wall

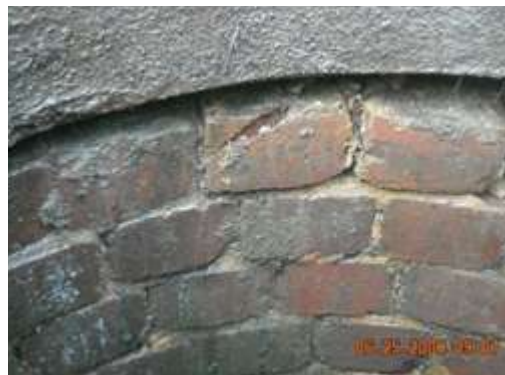
Defect 3

Condition: ☐ Sound ☒ **Cracked** ☐ Root Intrusion ☒ **Loose Brick** ☐ Deteriorated

cracked corbel bricks

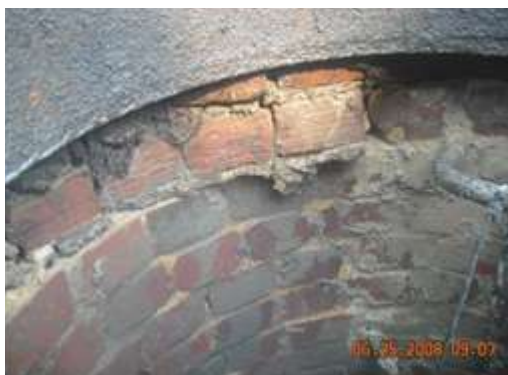
Defect 2

loose corbel bricks

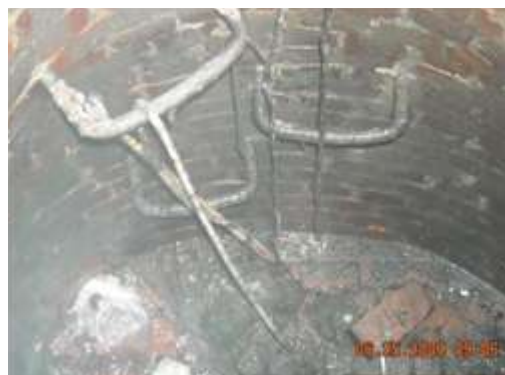
Defect 1

Condition: ☐ Sound ☐ Cracked ☐ Root Intrusion ☐ Deteriorated ☐ Leaks ☒ **Debris**

debris on bench

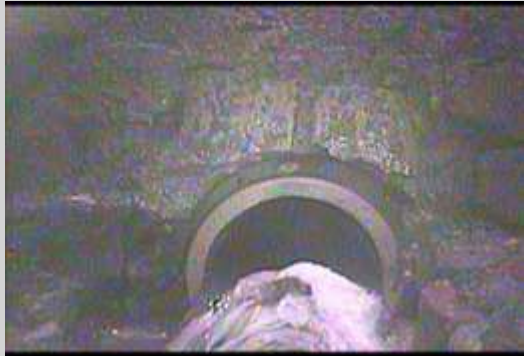
7 O'Clock Inflow

Deposits: ☐ None ☐ Mud ☒ ~~Sludge~~ **Debris** ☐ Grease

Silt Depth: **4** (in.) Deposits Extent: **Heavy**
